Dredging Inspection Field Report

Site Observations

Date: 10/12/2021 Field Engineer: Mike Triano
 Weather Conditions: Breezy, Overcast Temperature: 80s
 Wood Project Number: 2402210005.01.01 Client: Isle of Palms
 Contractor: Branch Diversified (BDI) Foreman Onsite: N/A

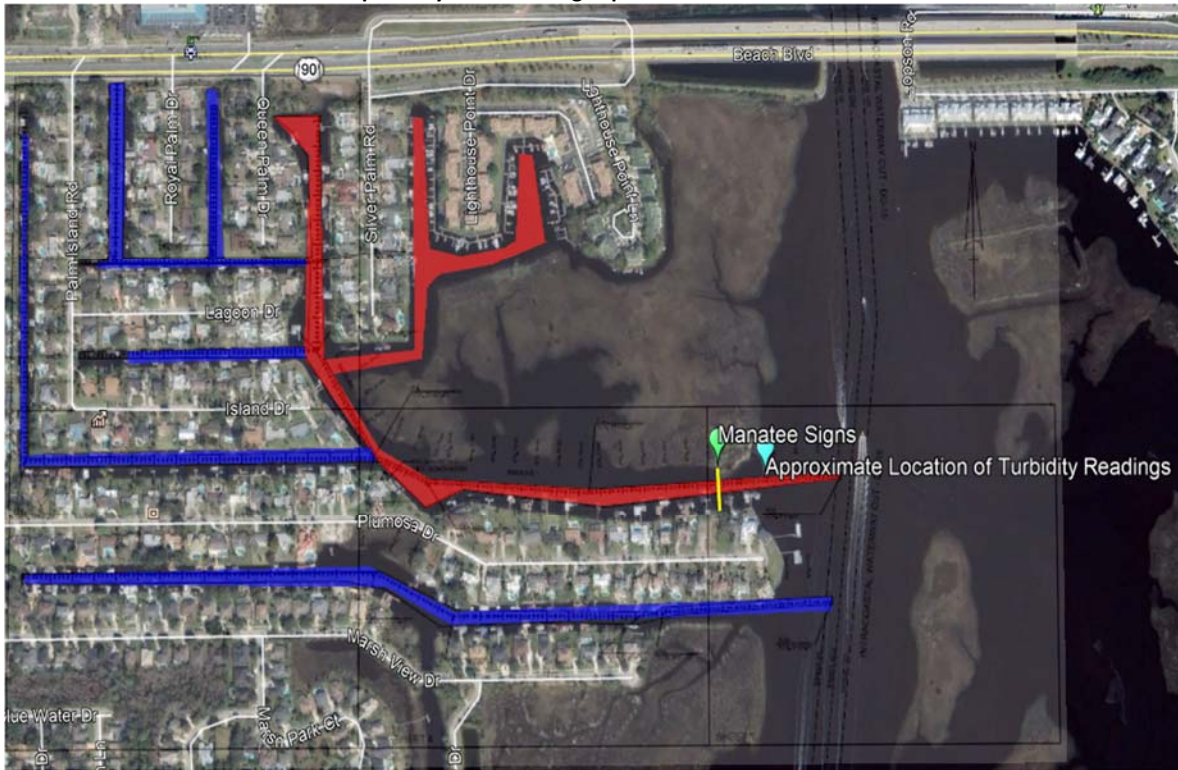
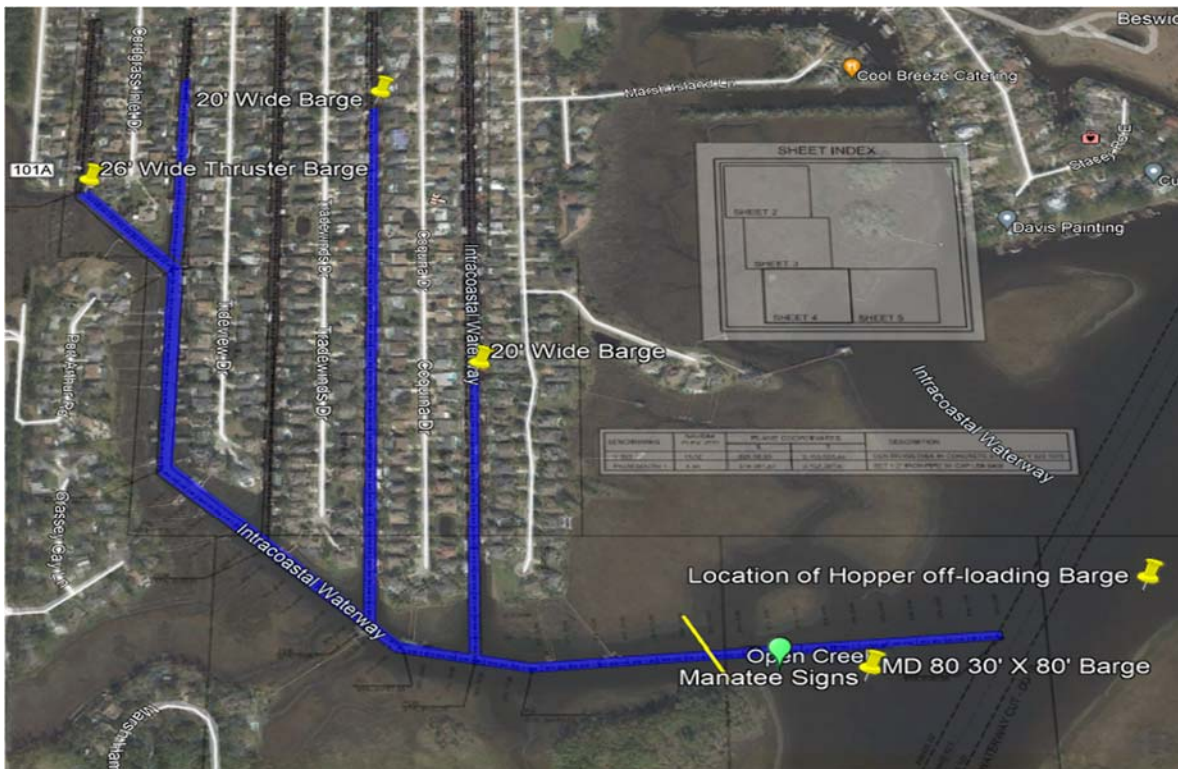
Maps: **Red** is completed Work **Blue** is Work to be completed

*BDI will return to Canals to clean up survey identified high spots
