## Dredging Inspection Field Report

### Site Observations

Date: 5/11/2021 Field Engineer: Mike Triano  
 Weather Conditions: Partly Sunny Temperature: 80s  
 Wood Project Number: 2402210005.01.01 Client: Isle of Palms  
 Contractor: Branch Diversidied (BDI) Foreman Onsite: Angel Guzman

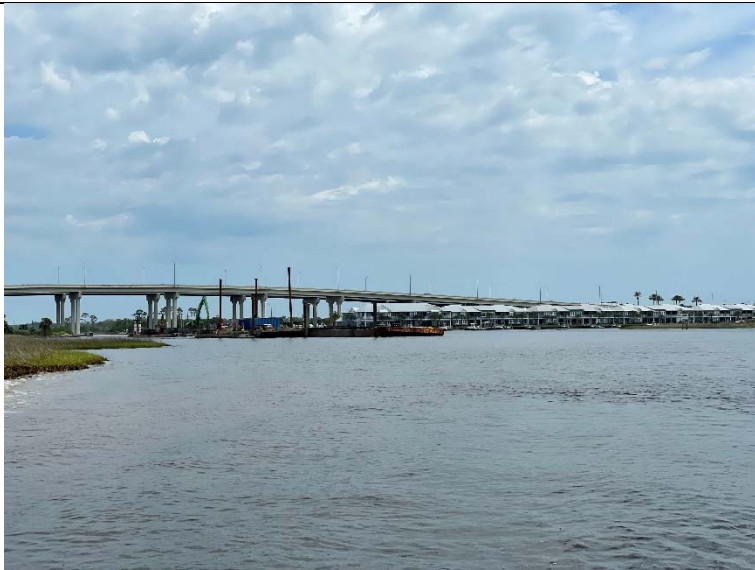
| Item | Observations | Photo |
|---|--|--|
| <b>Crew Size</b> | <p>Two 20' wide barges dredging at time of inspection.<br/> Two tugs to move the barges back and forth.<br/> One 26' Thruster Barge<br/> One ~ 50' X 100'+ Hopper barge staged in intracoastal east of mooring canals used to transport material to DMMA.<br/> Angel's ~20' aluminum boat</p> <p>One 30' x 80' barge placed in vicinity of Station 18 in Baseline 1 – N Canals. Barges will offload here to avoid trip to intracoastal. – This barge was not located in this position at the time of the inspection.</p> | Photo: 1 |

| <b>Offloading Location</b> | <p>Large ~80 -100+ foot storage barge located in the Intracoastal</p> <p>Angel advised that there are several barges of this size, and larger that are interchanged once full.</p> <p>Angel advised that trips to the DMMA are taken once these large barges are full, but that usually occurs once a day.</p> <p>30' x 80' barge located at Station 18, Baseline 1. Angel advised that the offloading of this barge varies, but at least off-loads once a day. – This barge was not located in this position at the time of the inspection.</p> | Photo: 1 |

**Photo 1:** Barges at idle, moored to large hopper barge in intracoastal.

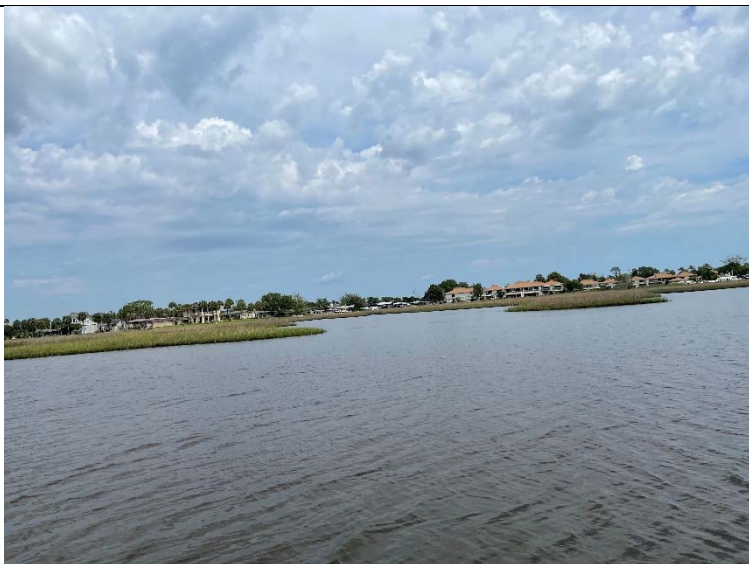
**Photo 2:** Photo towards Mooring canals where barges will resume dredging at low tide today, May 11, 2021.

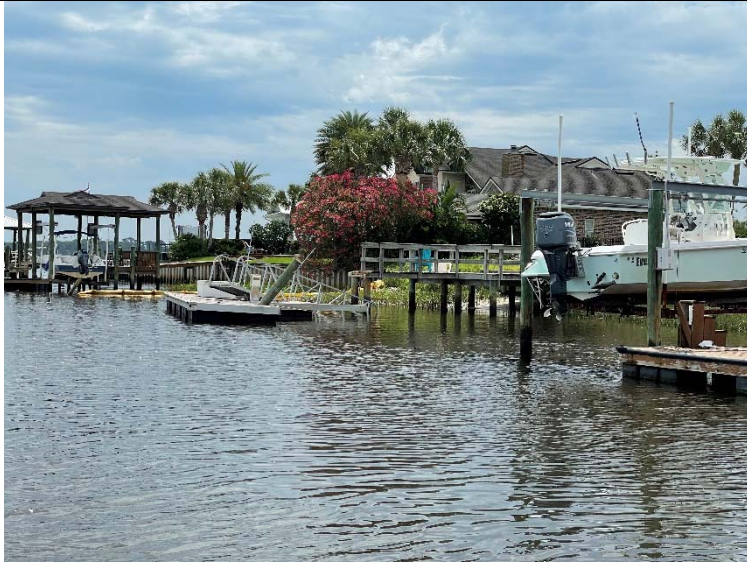
- Barge placement – will start reporting where barges are located at the time of the inspection for simplicity and difference in projected and actual locations of dredging.
- BDI indicated that there was an accident last week involving the 26' Thruster, and one of the 20' wide barges. BDI indicated that both barges made contact with several docks and several boats. See map and photos below (7 & 8) of observable damage at the time of the inspection.

**Photo 3:** Damaged dock at the end of Baseline 1.

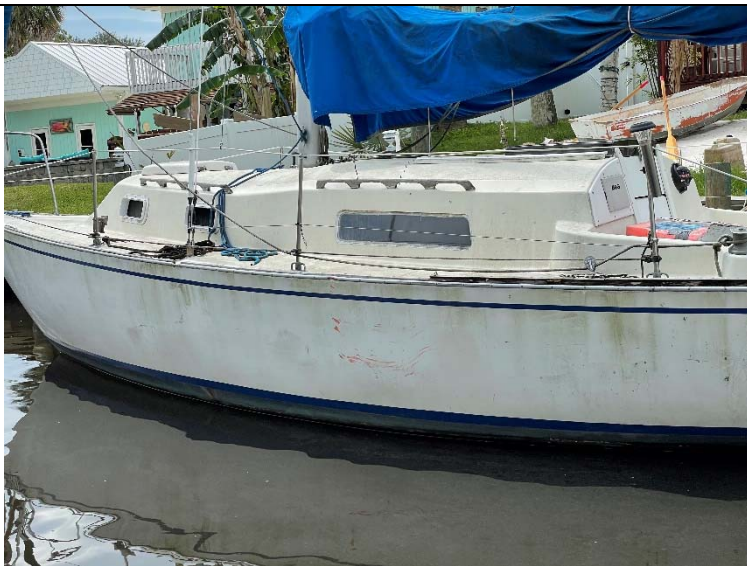
**Photo 4:** Damaged boat within Baseline 3.

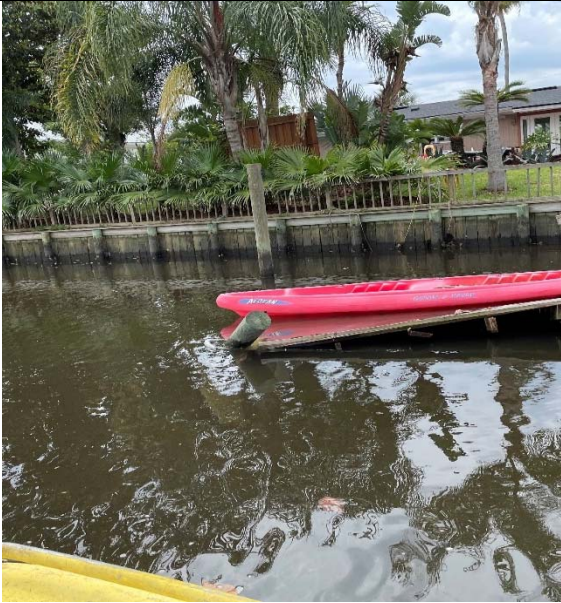
**Photo 5:** Damaged dock within Baseline 3.

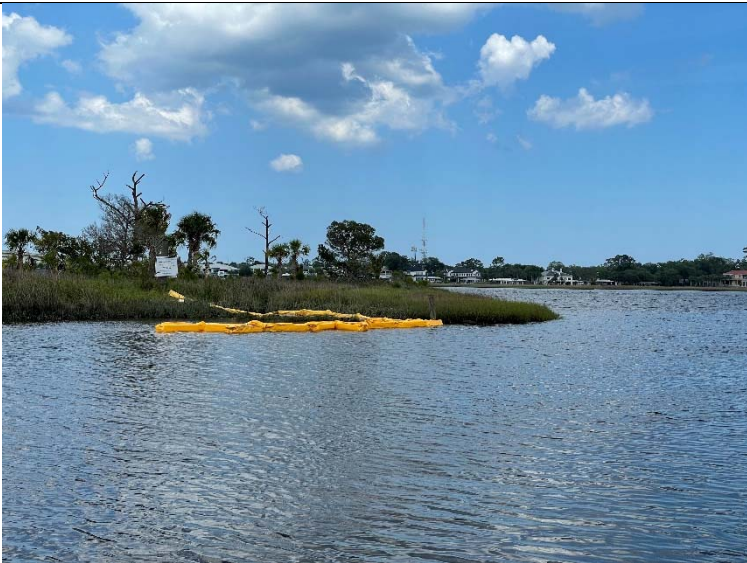
| <b>Manatee Observer</b> | All crew on barges were advised to keep eye out for Manatees - signs posted on northern and southern canals. | Photos: 6 |

**Photo 6:** New turbidity barrier and manatee signs.

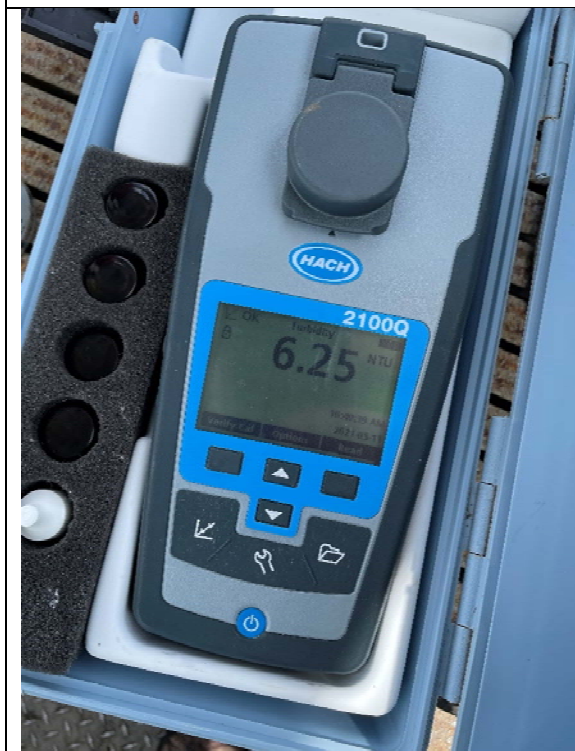
| <b>Turbidity Monitoring</b> | <p>0800 reading was 6.47 NTU<br/>1200 reading was 6.25 NTU</p> <p>Angel advised new, cable barrier was implemented</p> <p>Barrier was open at the time of the inspection.</p> | Photos: 7 & 8 |

**Photo 8:** 1200 turbidity reading taken at the time of the inspection. Reading of 6.25 NTU.
