## Dredging Inspection Field Report

### Site Observations

Date: 5/25/2021 Field Inspector: Mike Triano  
 Weather Conditions: Sunny Temperature: 80s / Windy  
 Wood Project Number: 2402210005.01.01 Client: Isle of Palms  
 Contractor: Branch Diversified (BDI) Foreman Onsite: Angel Guzman

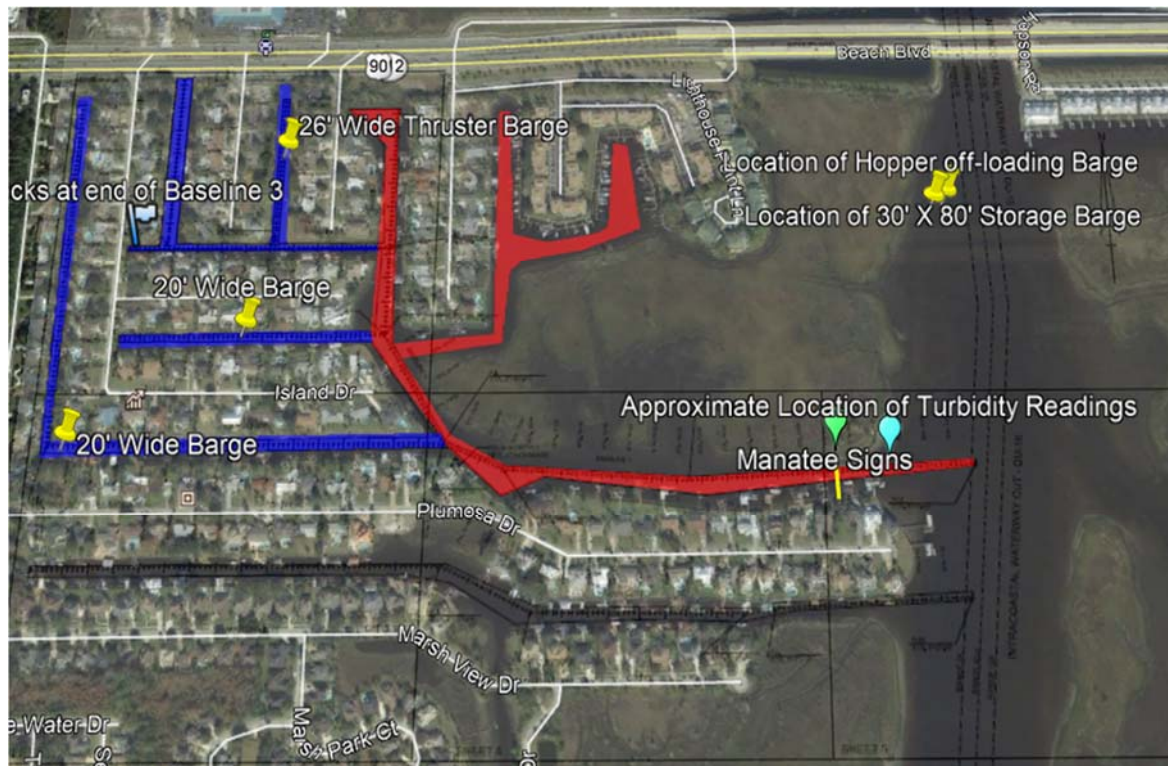
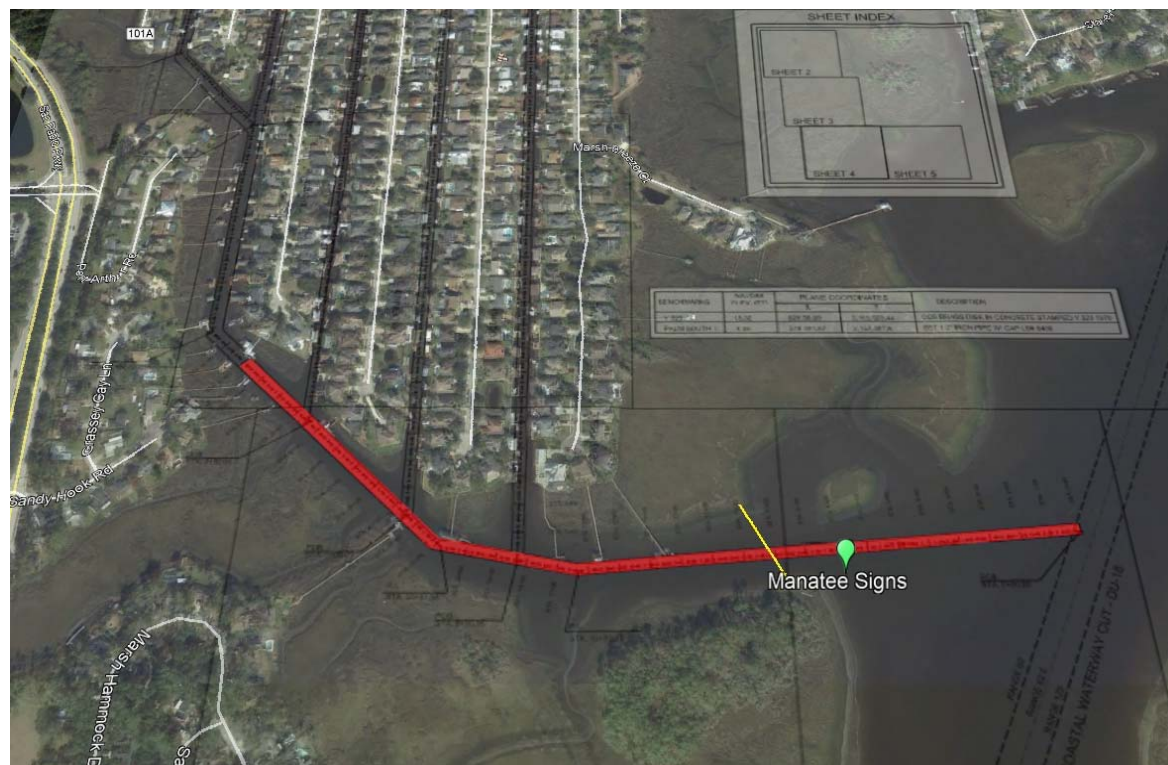
**Maps: Red is completed Work Blue is Work to be completed**

<b>Equipment on Site</b>	Same as Crew size, 4 mechanical dredges (excavators)	Photos: 1, 2, 5
<b>Work Completed</b>	S Baseline 1 from POB to ~ Station 31 Majority of N Baseline 1 to terminus - High spots remain: BDI indicated that any high spots identified will be corrected to the proper depth. Mooring Canals Portions of N Baseline 2, 3, 4, 5, & 6  BDI indicated that the Mooring Canals are now fully completed.  BDI advised dredging occurs in two phases: on the way in for access & removal of top layer of sediment and on the way out for getting canal to specified grade. This is true for all canals that barges cannot initially access.	See Map

<b>Work Underway</b>	Dredging was underway in Baseline 2, Baseline 6 and Baseline 7 at the time of the inspection.	See Map
<b>Materials on Site</b>	<p>Stored in ~100' + long X 50' wide Hopper barge and One 30' x 80' barge. Both barges were moored in the intracoastal at the time of the inspection.</p> <p>The 30' x 80' barge, typically located at Station 18, Baseline 1, was moored off to the large Hopper barge in the intracoastal at the time of the inspection. This barge was still being used to unload the smaller barges.</p> <p>Angel advised that trips to the DMMA are taken once these large barges are full, that usually occurs once a day.</p>	Photos: 3, 5
<b>Manatee Observer</b>	All crew on barges were advised to keep eye out for Manatees - signs posted on northern and southern canals.	Photo: 6
<b>Turbidity Monitoring</b>	<p>0800 reading was 8.08 NTU. 1200 reading was 29.6 NTU – taken at the time of the inspection.</p> <p><b>Note:</b> the 29.6 NTU reading is still within the acceptable threshold standard determined by 62 – 302.530 F.A.C. (70) (29 NTU above Natural Background Conditions) Control sample taken for today was the 0800 reading which was done before work commenced and read 8.08 NTU.</p> <p>Barrier was open at the time of the inspection.</p>	Photos: 4, 6

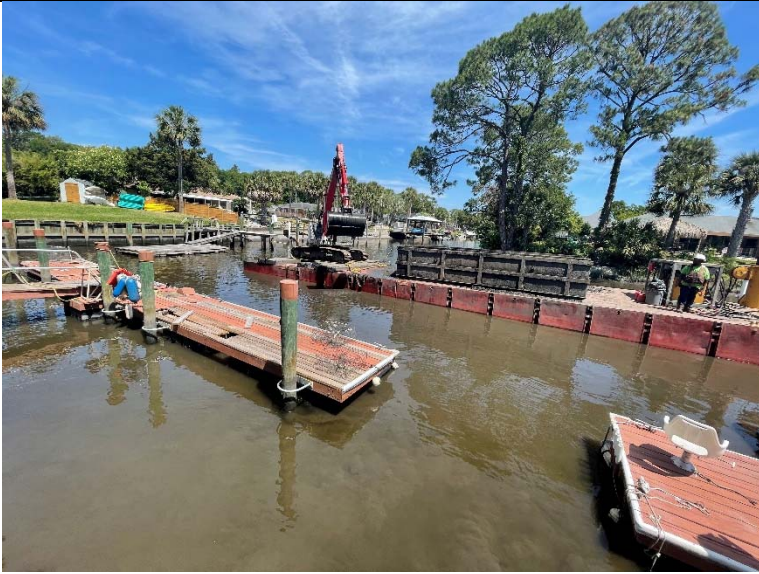
**Photo 1:** 20' Wide Barge actively dredging within Baseline 2.

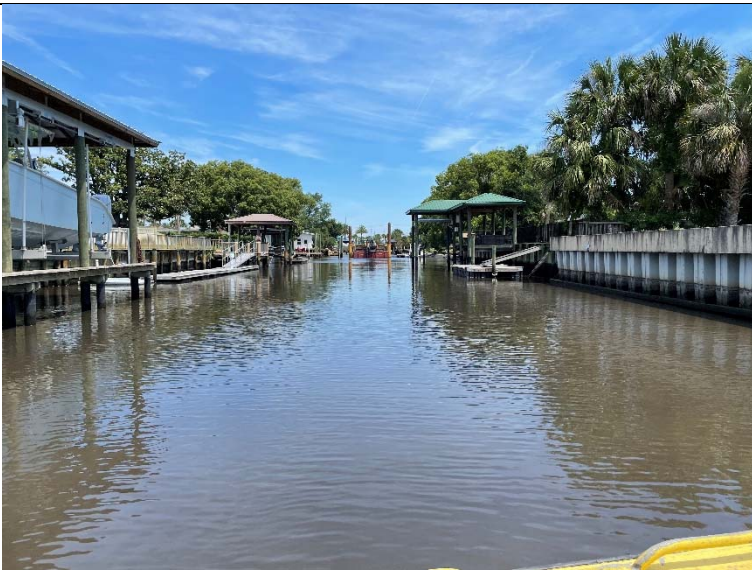
**Photo 2:** 26' Wide Thruster Barge actively dredging within Baseline 4.

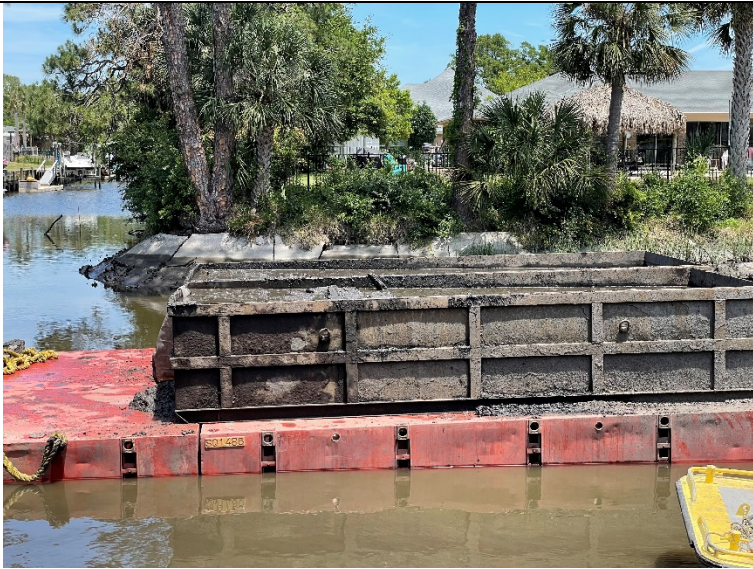
**Photo 3:** Material removed from Baseline 2.

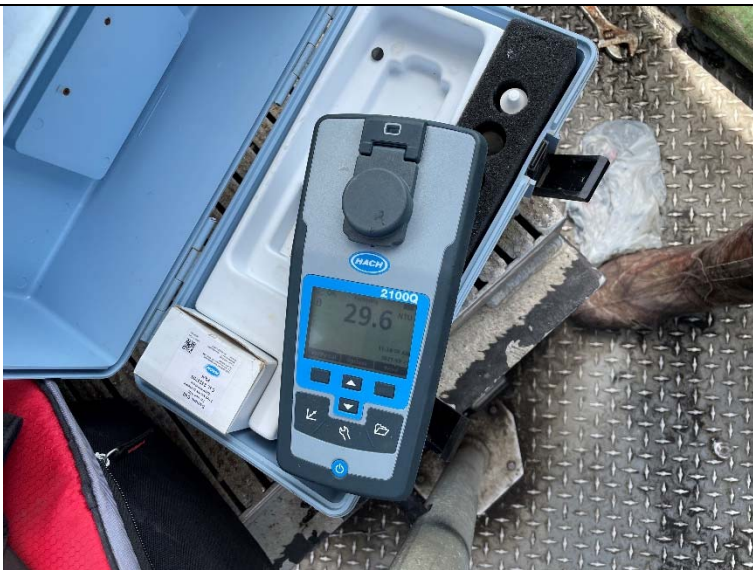
**Photo 4:** 1200 Turbidity Reading of 29.6 NTU.

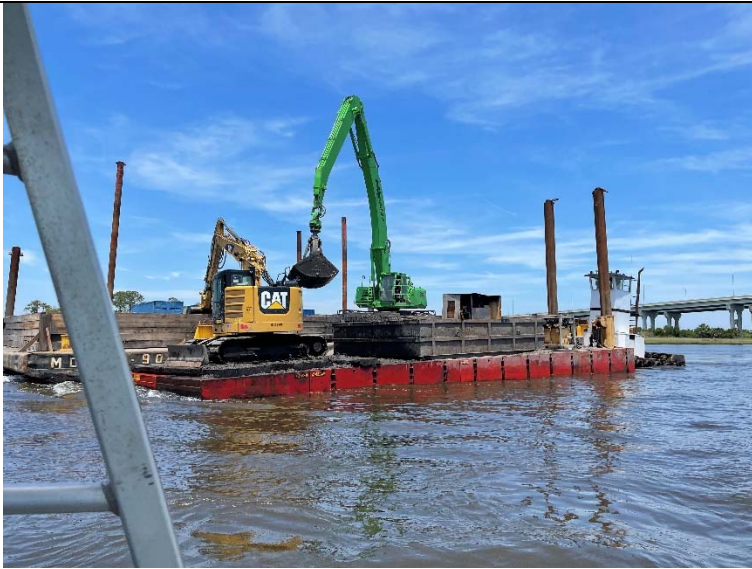
**Photo 5:** View of Barge setup in the intracoastal and active material removal from smaller, 20' wide barge at the time of the inspection.

Barge being off-loaded was the barge BDI indicated was working within Baseline 6.

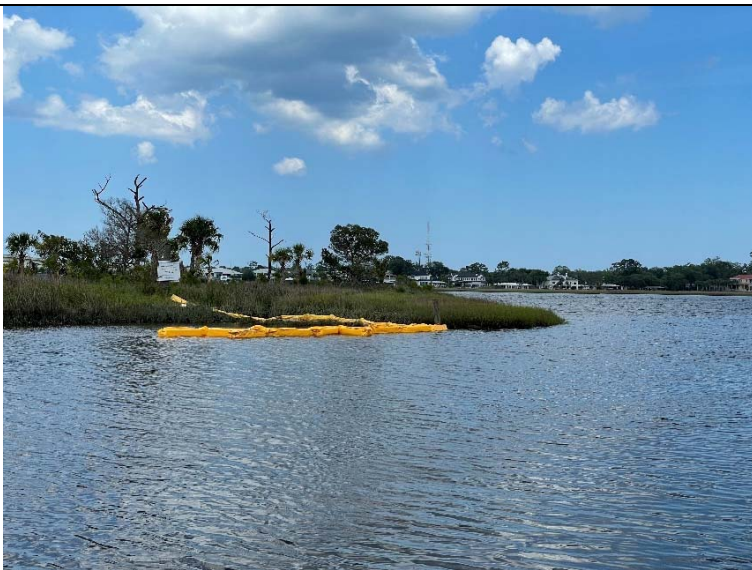
**Photo 6:** Turbidity barrier and manatee signs.

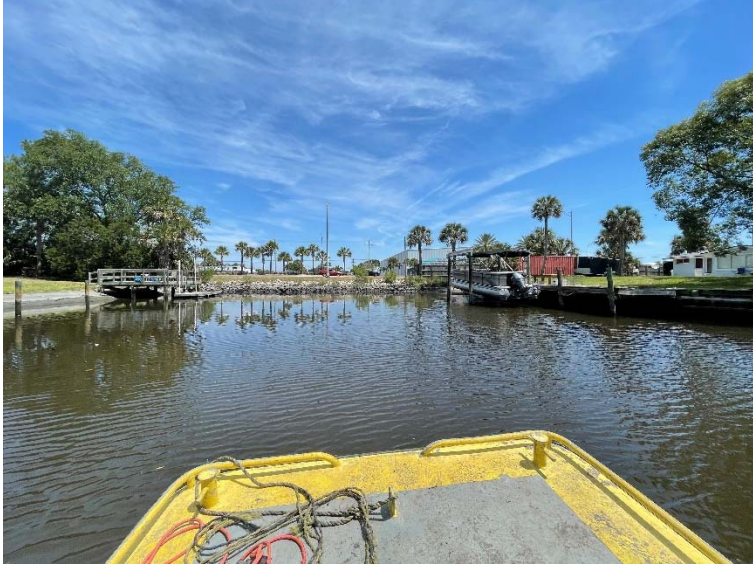
**Photo 7:** Typical view of riprap at terminus of Baseline 5.

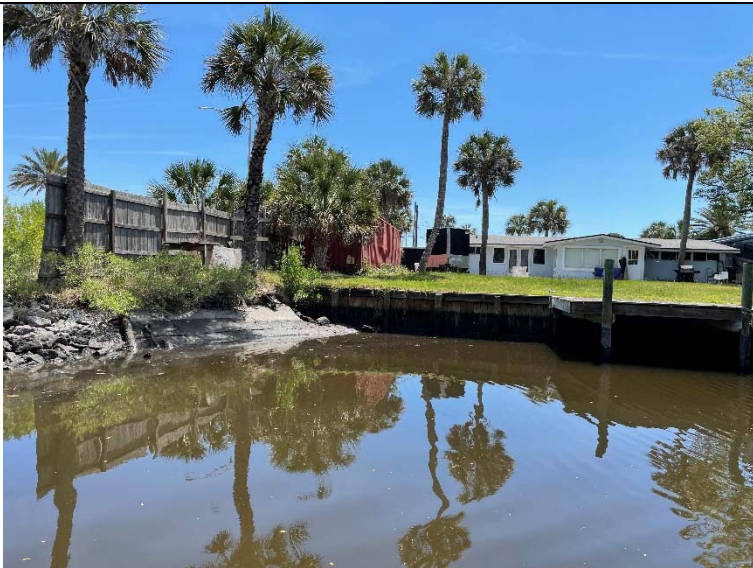
- BDI indicated that dredging of the terminus of Baseline 5 starts approximately 20 feet south of the riprap associated with Beach Blvd. See photo 8 for reference.
- BDI indicated that the northern most half of Baseline 5, (approximately from Station 3 to Station 7) was only 1 foot away from being at grade.
- BDI indicated that any high spots identified by the Arc Survey in Baseline 1 will be corrected to the proper depth.

**Photo 8:** For reference, BDI indicated that the dredge is parked parallel to the end of this dock (northern most dock in Baseline 5) during dredging activities.
