Dredging Inspection Field Report

Date: 8/4/2021 Field Engineer: Mike Triano
 Weather Conditions: Breezy, Overcast, Rainy Temperature: 80s
 Wood Project Number: 2402210005.01.01 Client: Isle of Palms
 Contractor: Branch Diversified (BDI) Foreman Onsite: Lance Young

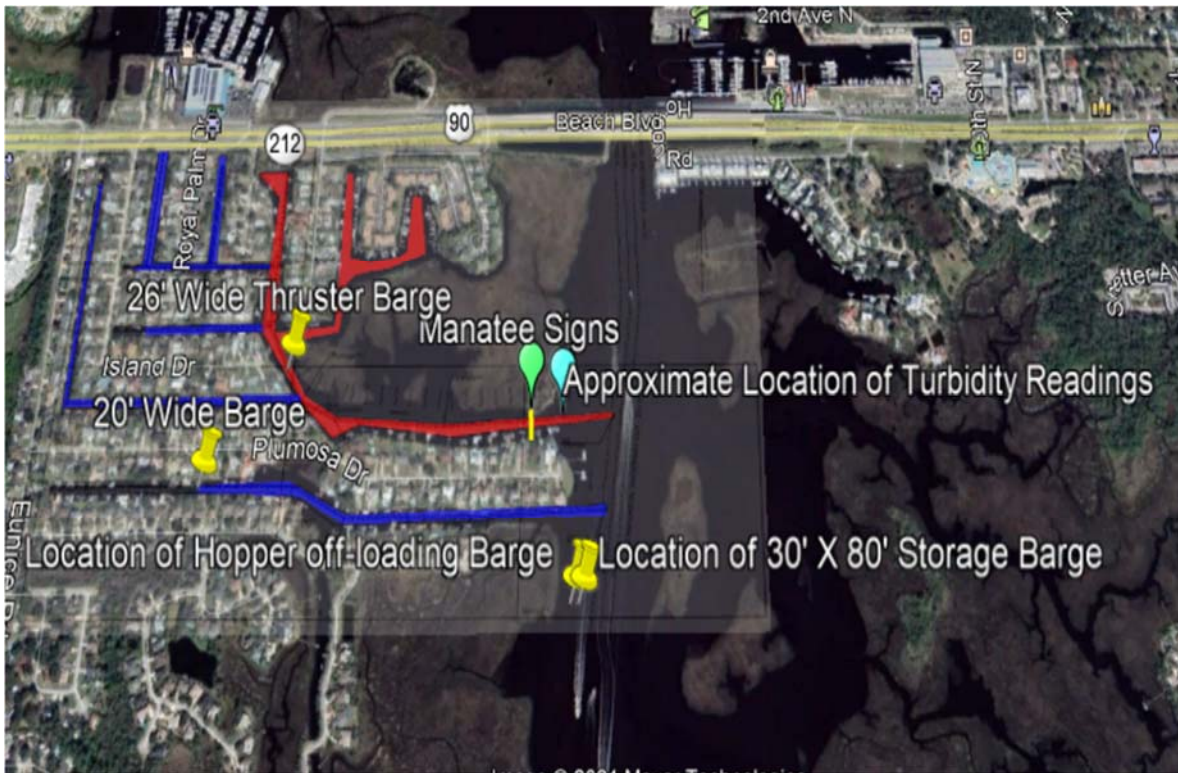
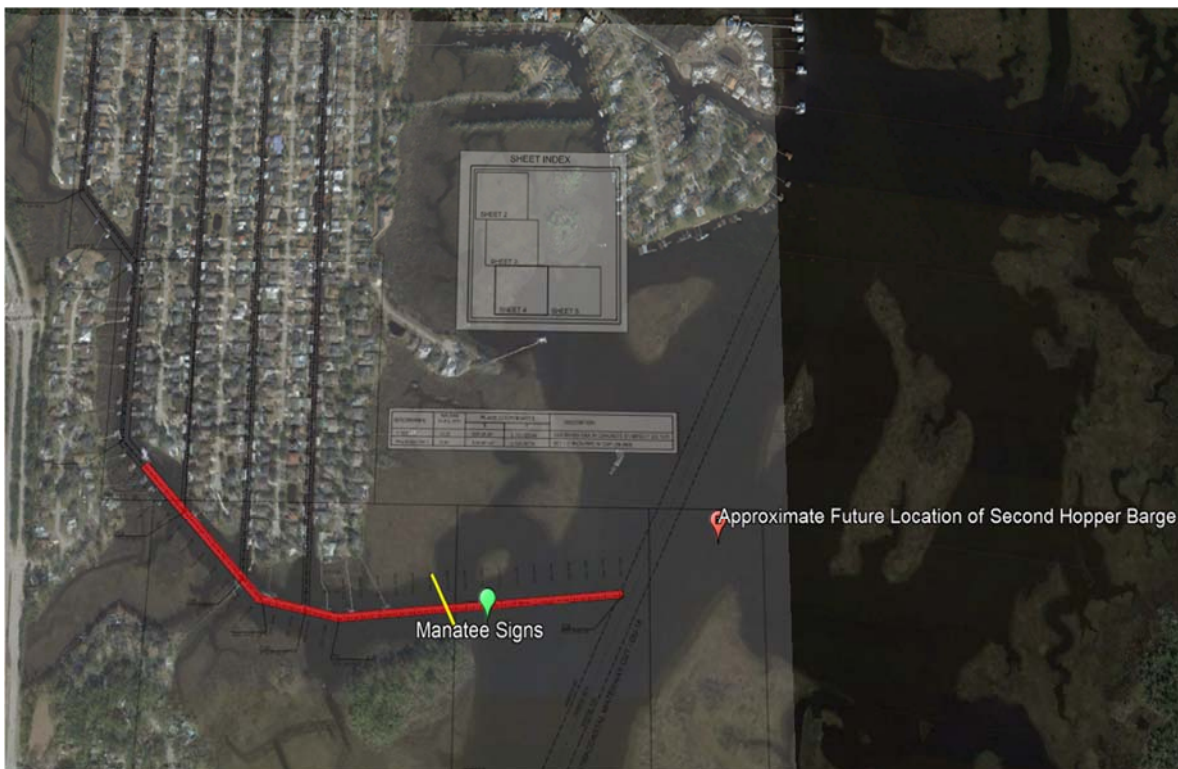
Maps: **Red** is completed Work **Blue** is Work to be completed

Equipment on Site	Same as Crew size, 4 mechanical dredges (excavators)	Photos: 1, 2 & 3
Work Completed	<p>S Baseline 1 from POB to ~ Station 31</p> <p>Majority of N Baseline 1 to terminus:</p> <p>Correction of High Spots within Baseline 1</p> <p>Mooring Canals</p> <p>Portions of N Baseline 2, 3, 4, 5, & 6</p> <p><u>BDI advised dredging occurs in two phases: on the way in for access & removal of top layer of sediment and on the way out for getting canal to specified grade. This is true for all canals that barges cannot initially access.</u></p>	See Map
Work Underway	<p>Actively Dredging Baseline 7 North IOP</p> <p>Actively Dredging Identified Additional Material / Correcting High spots in Baseline 1 North IOP</p>	See Map
Materials on Site	<p>Stored in ~ 50' x 100'+ Hopper barge and One 30' x 80' barge. Both barges are moored in the intracoastal. Southeast of Baseline 7.</p> <p>Lance indicated that once dredging commences in the South IOP Canals, a second Large ~ 50' x 100'+ will be stored on pilings east of the entrance to the southern canals.</p>	Photo: 2 & 3

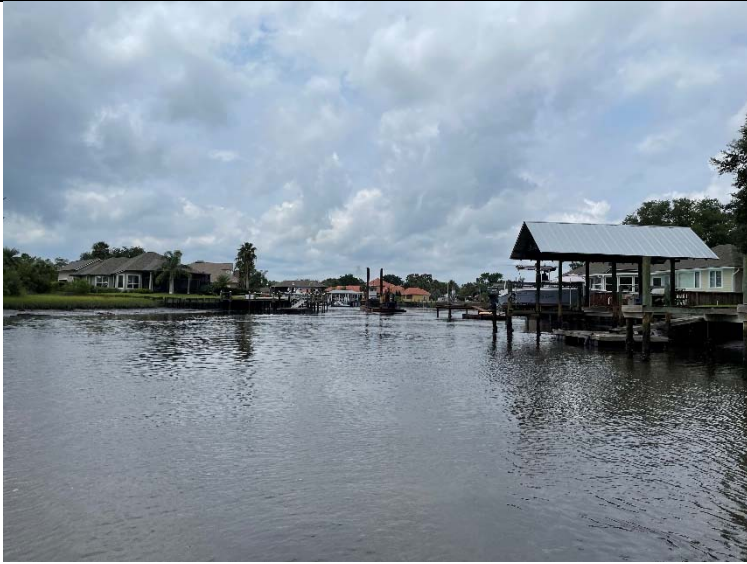
Photo 1: View of 20' Wide Push Barge returning to Baseline 7 after off – loading.

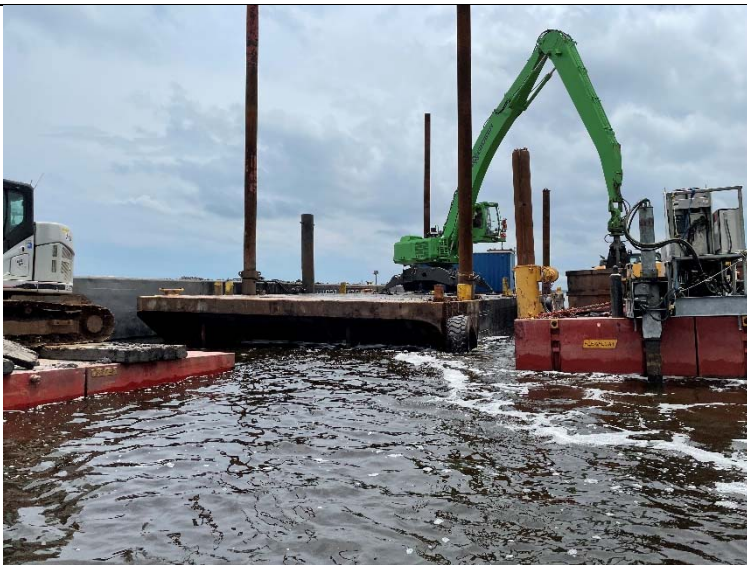
Photo 2: View of 26' Thruster Barge actively off-loading before returning to Baseline 1.

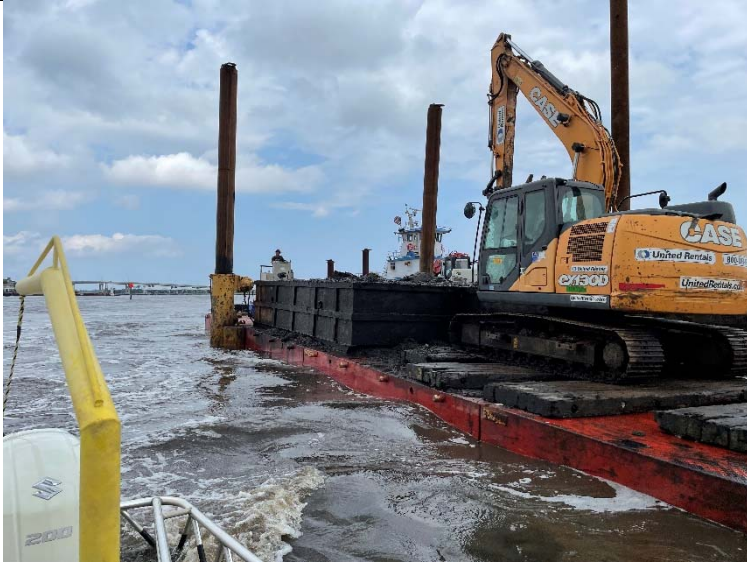
Photo 3: Additional photo of 26' Thruster Barge full of material off-loading to the Hopper storage barge.
