## Dredging Inspection Field Report

Date: 5/18/2021 Field Inspector: Mike Triano

Wood Project Number: 2402210005.01.01 Client: Isle of Palms

Contractor: Branch Diversidied (BDI) Foreman Onsite: Angel Guzman

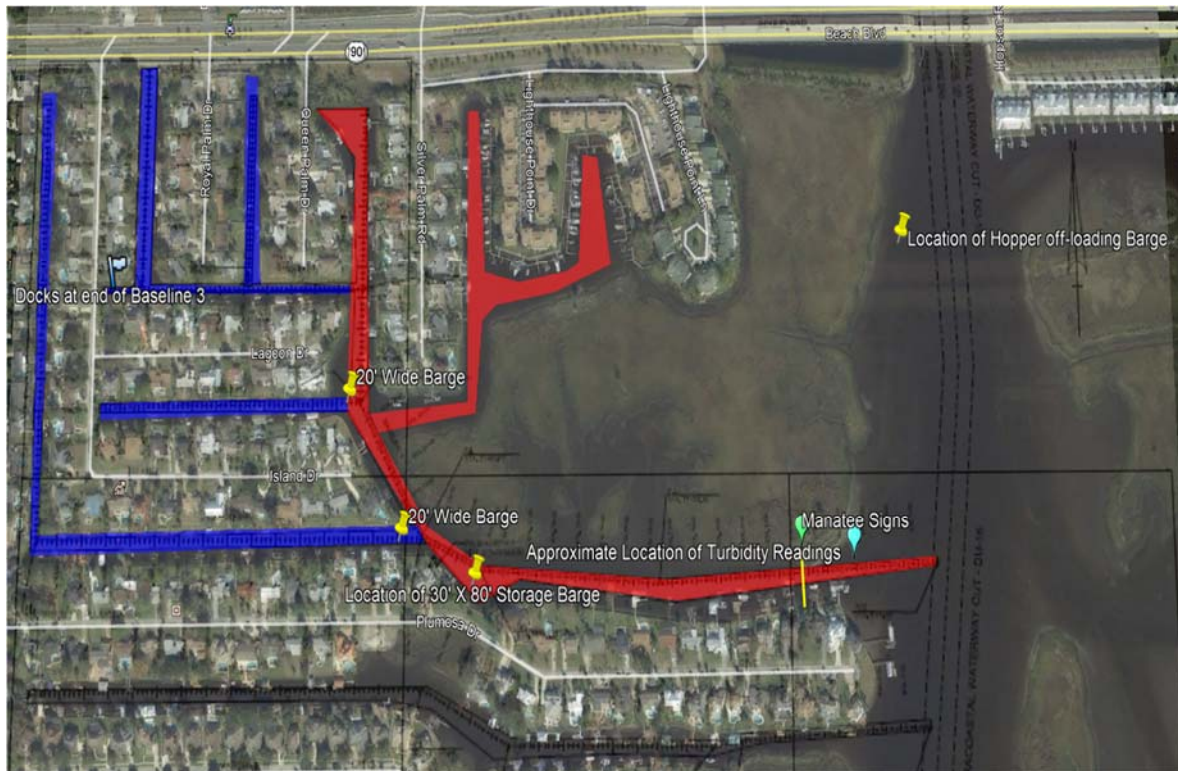
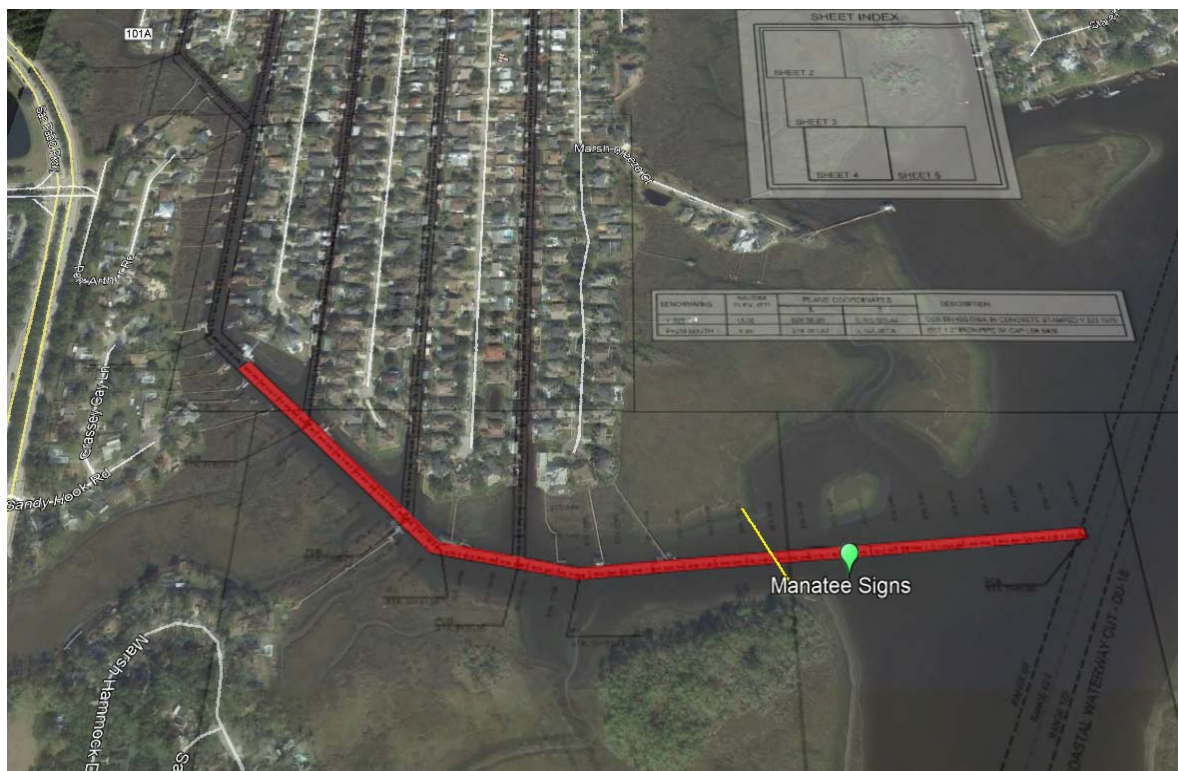
Maps: **Red** is completed Work **Blue** is Work to be completed

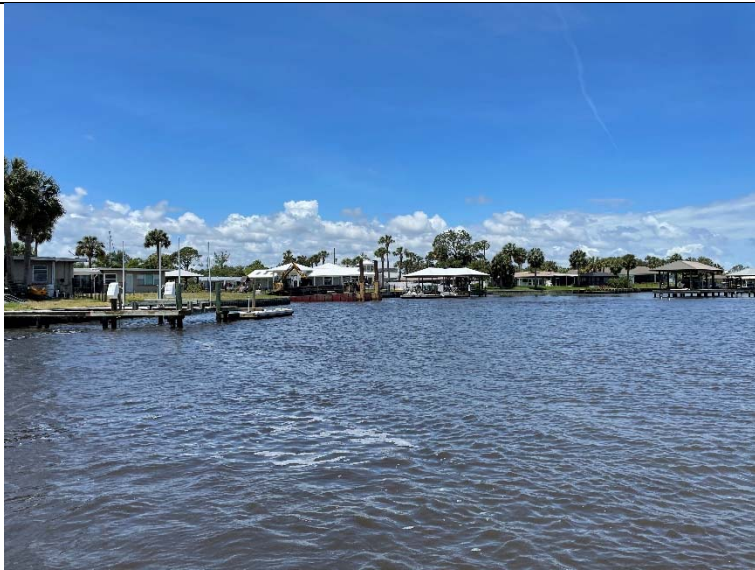
**Photo 1:** 20' Wide Barge actively dredging within Baseline 6.

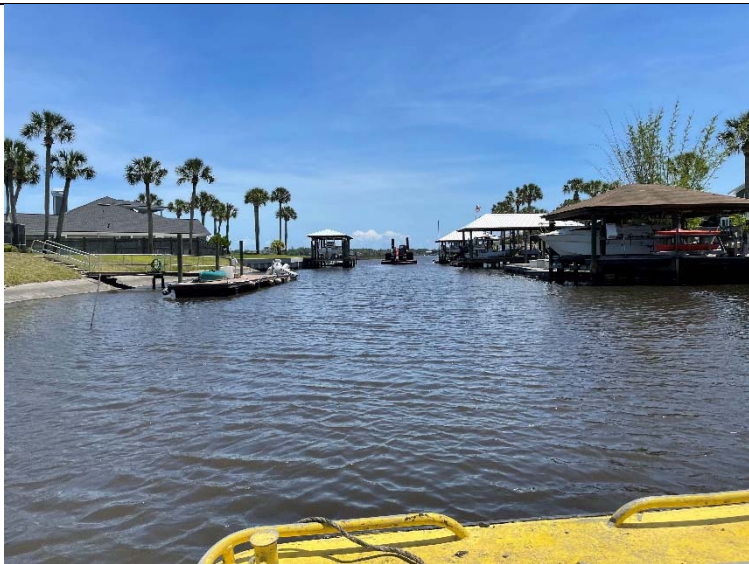
**Photo 2:** 20' Wide Barge actively dredging within Baseline 2.

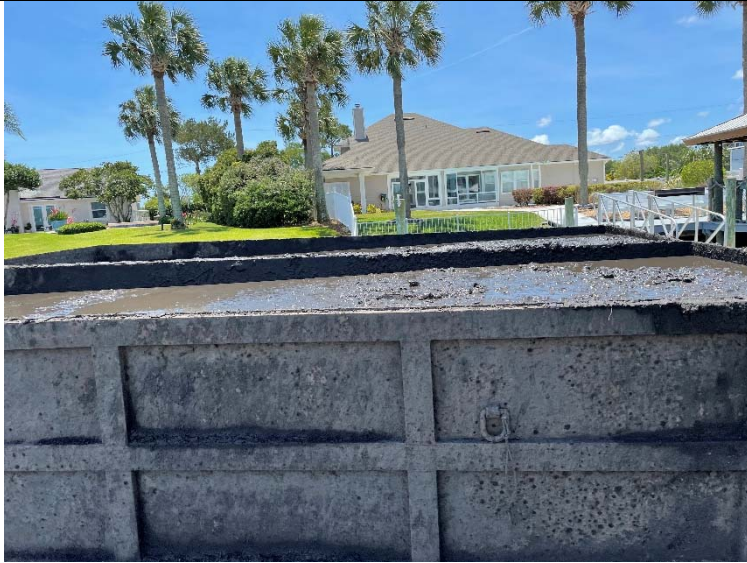
**Photo 3:** Material removed from Baseline 2.

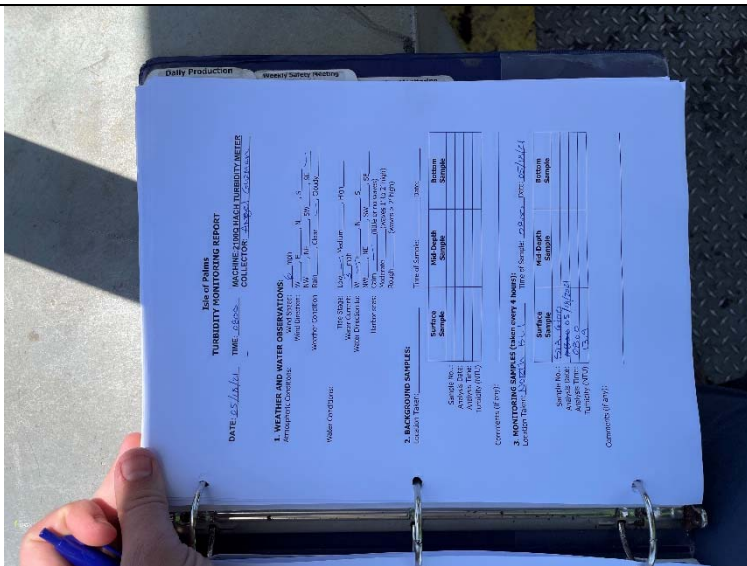
**Photo 4:** 0800 Turbidity monitoring form – reading was 13.9 NTU

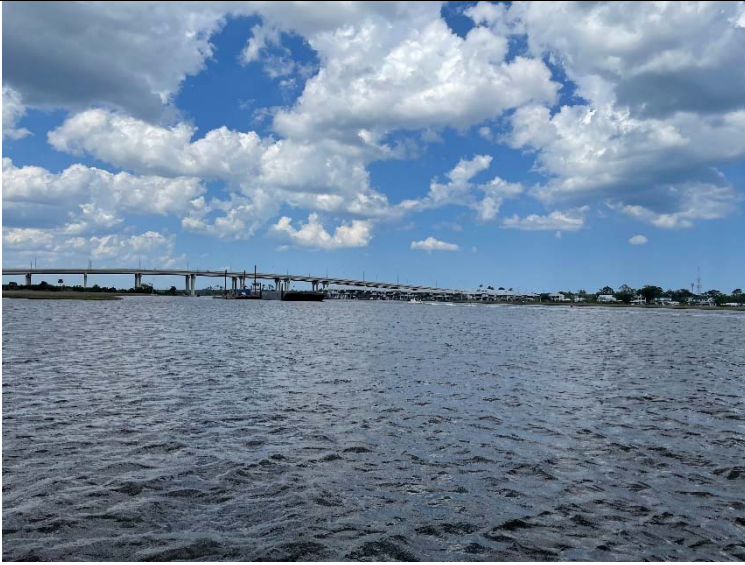
**Photo 5:** Typical view of large ~ 50' X 100'+ hopper barge used as transport to DMMA.

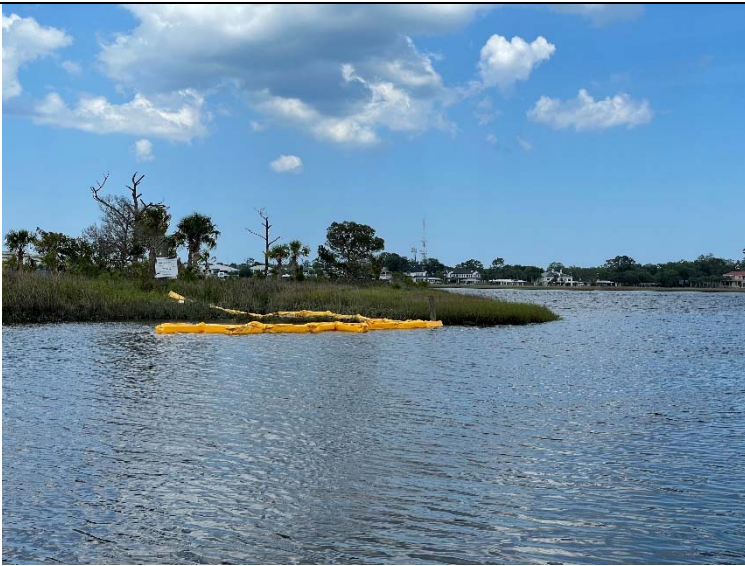
**Photo 6:** Turbidity barrier and manatee signs.

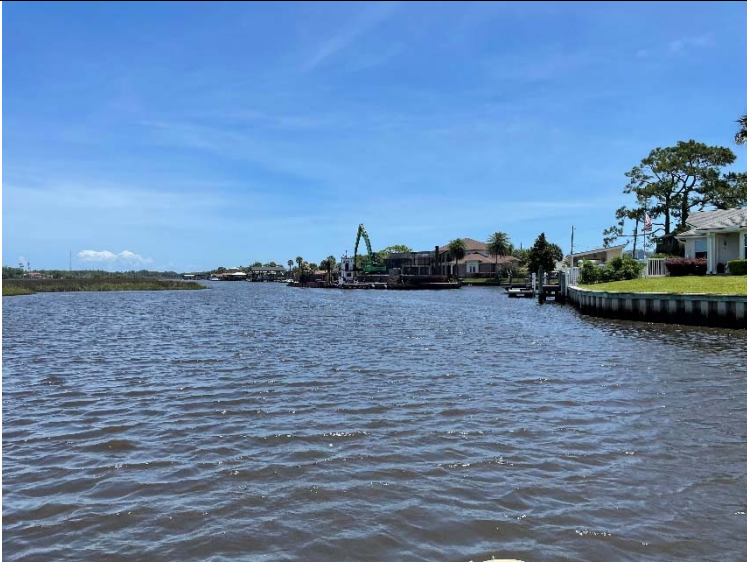
**Photo 7:** One 30' x 80' barge placed in vicinity of Station 18 in Baseline 1 – N Canals. 20' Wide Barge Actively unloading

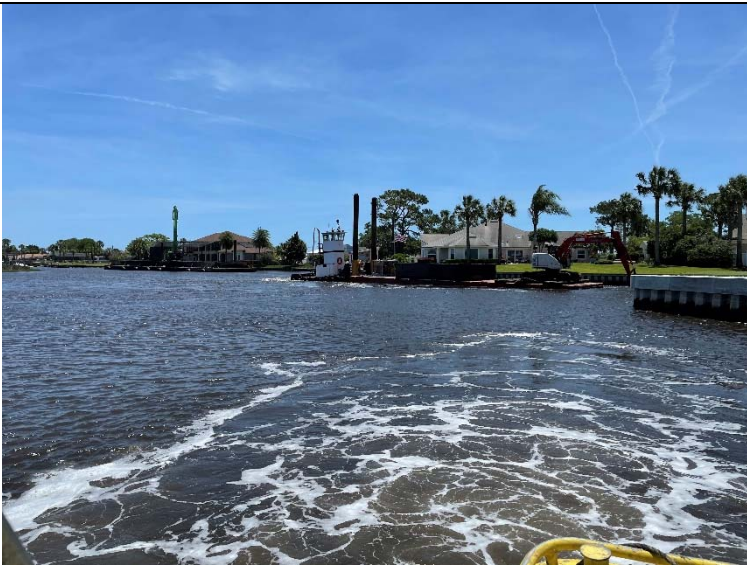
**Photo 8:** Typical view of tug maneuvering barge.
