Dredging Inspection Field Report

Site Observations

Date: 6/9/2021 Wood Field Engineer: Mike Triano & Charlene Stroehlen

Wood Project Number: 2402210005.01.01 Client: Isle of Palms

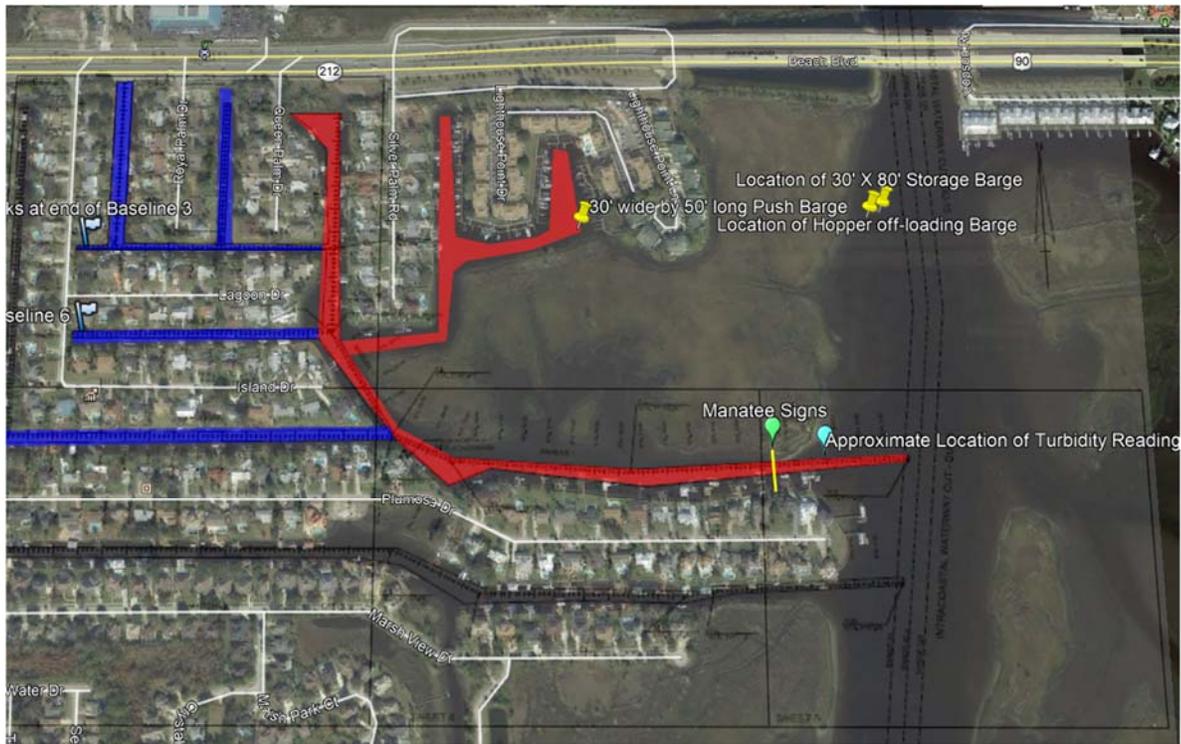
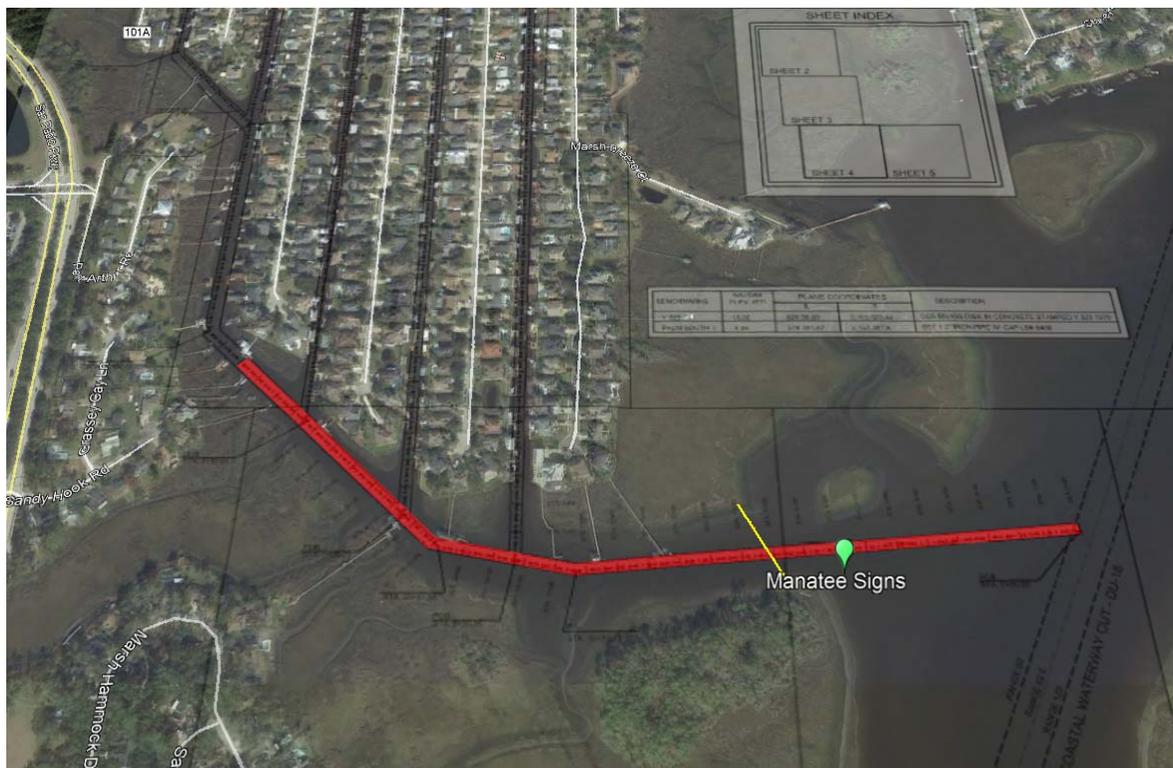
Maps: **Red** is completed Work **Blue** is Work to be completed

Work Completed	<p>S Baseline 1 from POB to ~ Station 31 Majority of N Baseline 1 to terminus - High spots remain: BDI indicated that any high spots identified will be corrected to the proper depth.</p> <p>Mooring Canals</p> <p>Portions of N Baseline 2, 3, 4, 5, & 6</p> <p>BDI indicated that continued clean up of the Mooring & Autobahn Canals are underway.</p> <p><u>BDI advised dredging occurs in two phases: on the way in for access & removal of top layer of sediment and on the way out for getting canal to specified grade. This is true for all canals that barges cannot initially access.</u></p>	<p>See Map</p>

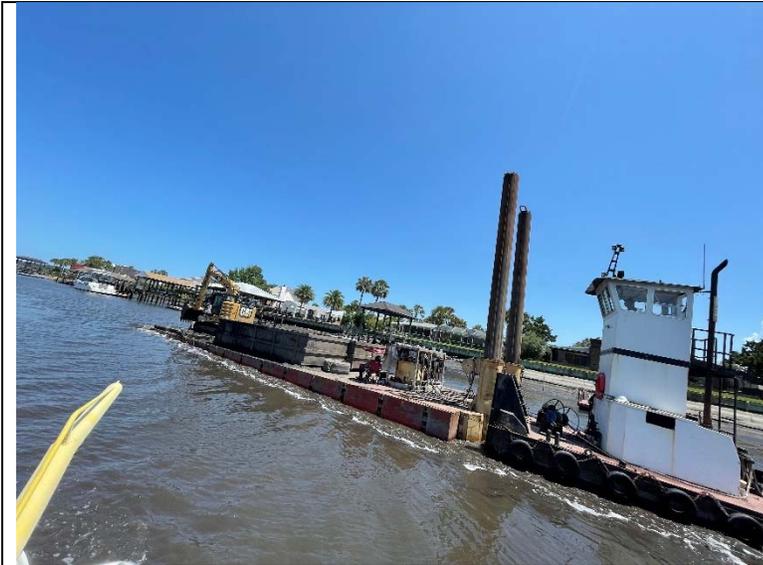
Item	Observations	Photo
Crew Size & Location	<p>The 30' x 80' barge, typically located at Station 18, Baseline 1, was moored off to the large Hopper barge in the intracoastal at the time of the inspection. This barge was still being used to unload the smaller barges.</p> <p>A second 30' X 80' barge was being utilized to continue work within the Mooring / Autobahn Canals cleaning up high spots.</p> <p>The two 20' wide push barges and tugs were being utilized as shuttles for the large 30' X 80' barge dredging the Mooring / Autobahn canals.</p> <p>One 26' Thruster Barge – Not actively dredging at the time of the inspection</p> <p>One ~ 50' X 100'+ Hopper barge staged in intracoastal east of mooring canals used to transport material to DMMA.</p> <p>Angel's ~20' aluminum boat</p>	<p>Photo: 1, 2, 5</p> <p>See Map</p>
Equipment on Site	<p>Same as Crew size, 4 mechanical dredges (excavators), and the inactive 26' Thruster Barge</p>	<p>Photos: 1, 2, 5</p>

Photo 1: Tug pushing 20' wide barge to off load.

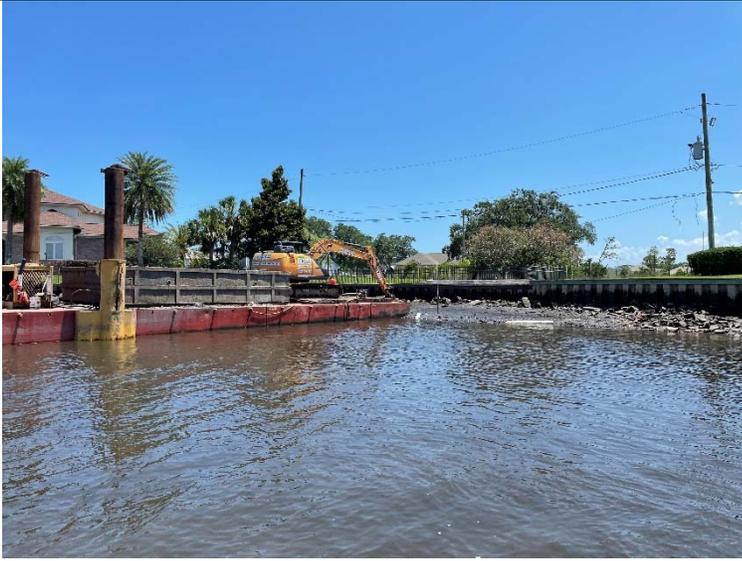
- Equipment malfunctioning / no operator to dig. The 26' wide thruster barge was not in operation due to there not being an operator to run the dredge. – Photo 3
- The very end of Baseline 3 and Baseline 6 will have to be finished at a later time, current dredges do not have a long enough boom to reach past the two docks at the end of the canals.
- Continued cleanup of canals outside of the IOP District. This also affects the planned schedule and resident's ability to move boats blocking access.
- Warmer weather increasing Manatee Traffic

Photo 3: Inactive 26' Thruster Barge.

- The 26' Thruster Barge, when manned by an operator, will continue to dredge within Baseline 4. Angel indicated that this barge would be able to correct the spots above grade in Baseline 1 once he reviews the survey and identified high spots. He indicated that he was not provided a copy of this survey to review.

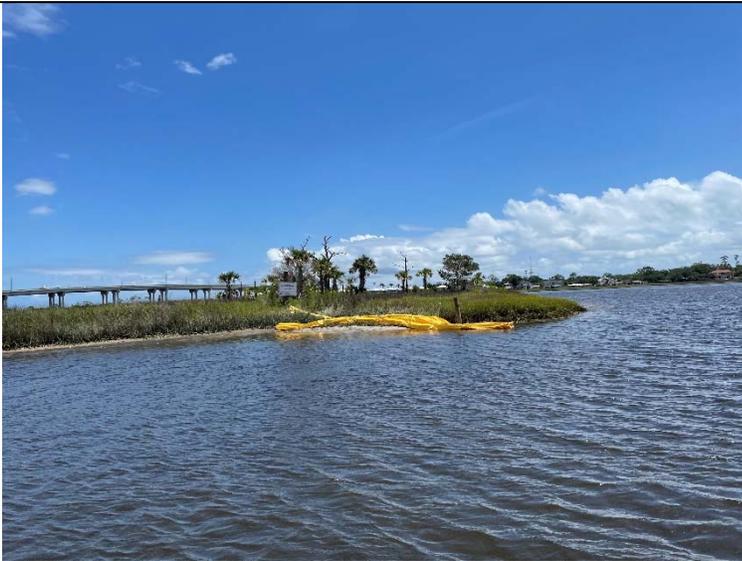
Work Underway	Cleanup dredging of Mooring & Autobahn Canals, outside of the IOP District	See Map
Materials on Site	<p>Stored in ~100'+ long X 50' wide Hopper barge and One 30' x 80' barge. Both barges were moored in the intracoastal at the time of the inspection.</p> <p>The 30' x 80' barge, typically located at Station 18, Baseline 1, was moored off to the large Hopper barge in the intracoastal at the time of the inspection. This barge was still being used to unload the smaller barges.</p> <p>The two 20' wide push barges and tugs were being utilized as shuttles for the large 30' X 80' barge dredging the Mooring / Autobahn canals.</p> <p>Angel advised that trips to the DMMA are taken once these large barges are full, but that usually occurs once a day.</p>	Photo: 1 & 5
Manatee Observer	All crew on barges were advised to keep eye out for Manatees - signs posted on northern and southern canals.	Photos: 4

Turbidity Monitoring	<p>0800 reading was 9.95 NTU 1200 reading was 16.6 NTU – taken at the time of the inspection.</p> <p>Barrier was open at the time of the inspection.</p>	Photos: 4
Dewatering	Lance advised dewatering does not occur - drain holes are located in bottom of containers. Lance advised inner canals are mixing zones and therefore sediment/water returning to canals are not of concern.	N/A
Dredging	Mechanical	
Offloading Location	<p>Large ~80 -100+ foot storage barge located in the Intracoastal. Angel advised that there are several barges of this size, and larger that are interchanged once full.</p> <p>The 30' x 80' barge, typically located at Station 18, Baseline 1, was moored off the large Hopper barge in the intracoastal at the time of the inspection. This barge was still being used to unload the smaller barges.</p> <p>Angel advised that trips to the DMMA are taken once these large barges are full, but that usually occurs once a day.</p>	Photo: 5

Photo 4: Typical turbidity barrier and manatee signs

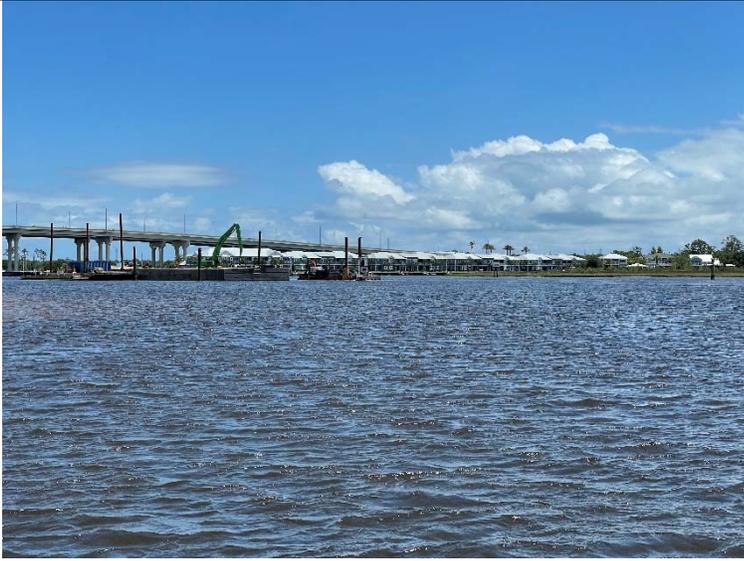
Photo 5: Typical view of offloading point in the intercoastal for the smaller barges.
