Dredging Inspection Field Report

Site Observations

Date: 9/22/20	<u>21</u> F	ield Engineer:	Mike Triano	
Weather Conditions:	Breezy, Overcast		Temperature:	80s
Wood Project Number:	2402210005.01.01	Client: <u>Isle</u>	of Palms	
Contractor: <u>Branch D</u>	iversified (BDI)	Foreman Onsit	e: <u>Brett Tucker</u>

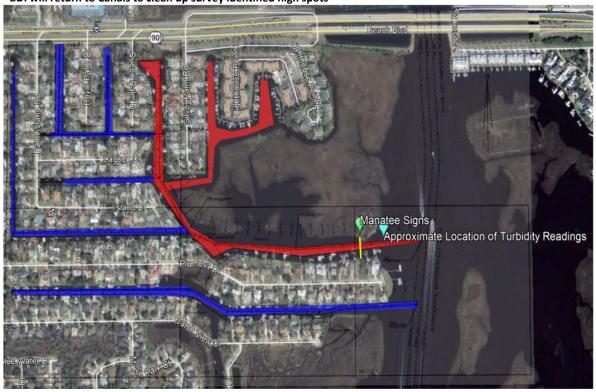
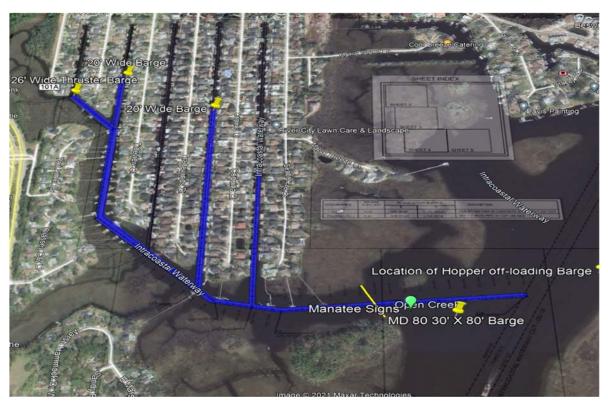
Maps: Red is completed Work Blue is Work to be completed *BDI will return to Canals to clean up survey identified high spots

^{*}BDI will return to Canals to clean up survey identified high spots

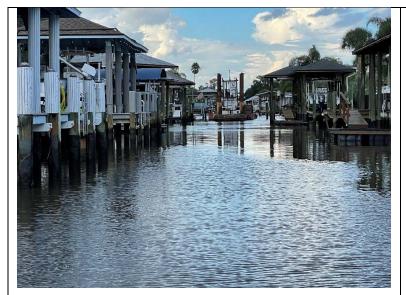
Photo 1: View of 20' Wide Push Barge located in Baseline 4: Southern IOP

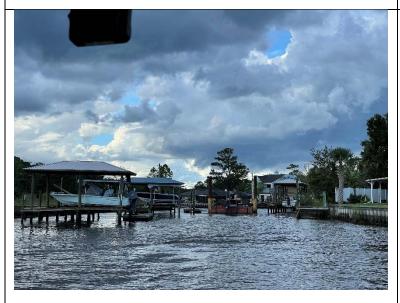
Photo 2: View of 26' Thruster Barge located in Baseline 1: Southern IOP.

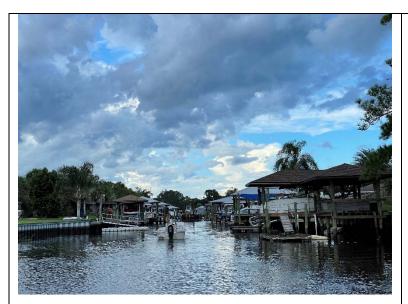
Photo 3: View of 20' Wide Push Barge located in Baseline 2: Southern IOP

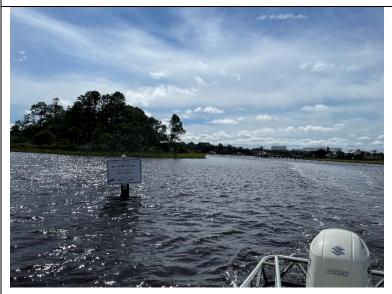
Photo 4: Typical view towards mouth of Baseline 1: Southern IOP. Manatee Signs and Turbidity Curtain visible in the distance.

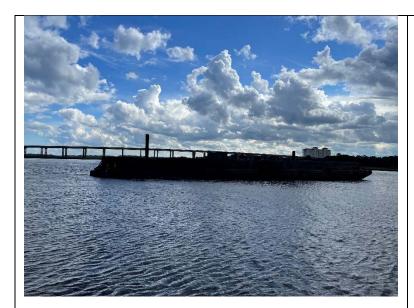
Photo 5: "MD - 80" 30' X 80' Barge utilized to off-load smaller barges staged near the mouth of Baseline 1 in the intracoastal.

- MD-80 Barge is utilized as an off-loading point during the day and is emptied into the larger Hopper barges in the evenings to cut off-loading time and reach the 5 to 6 load goal.
- Material in the southern canals contains organic matter (tree limbs/trunks) as well as sand and clay.
- Tuesday (9/21), the large tug Ol' Glory was fixed and able to move full Hopper barges to DMMA again.

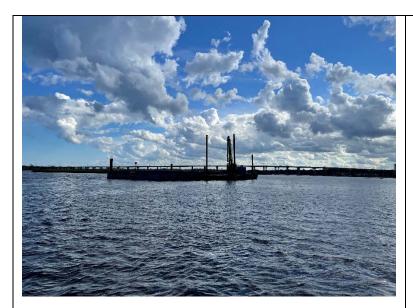
Photo 7: View towards large Hopper Barge staged east of the South IOP canals.

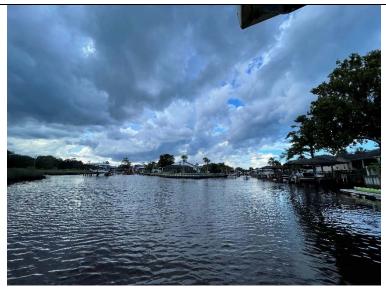
Photo 8: Additional Photo of Baseline 1 and Baseline 2 in South IOP. Both 26' Thruster and 20' Push Barges visible in background.
