## Dredging Inspection Field Report

### Site Observations

Date: 5/11/2021 Field Engineer: Mike Triano  
 Weather Conditions: Partly Sunny Temperature: 80s  
 Wood Project Number: 2402210005.01.01 Client: Isle of Palms  
 Contractor: Branch Diversidied (BDI) Foreman Onsite: Angel Guzman

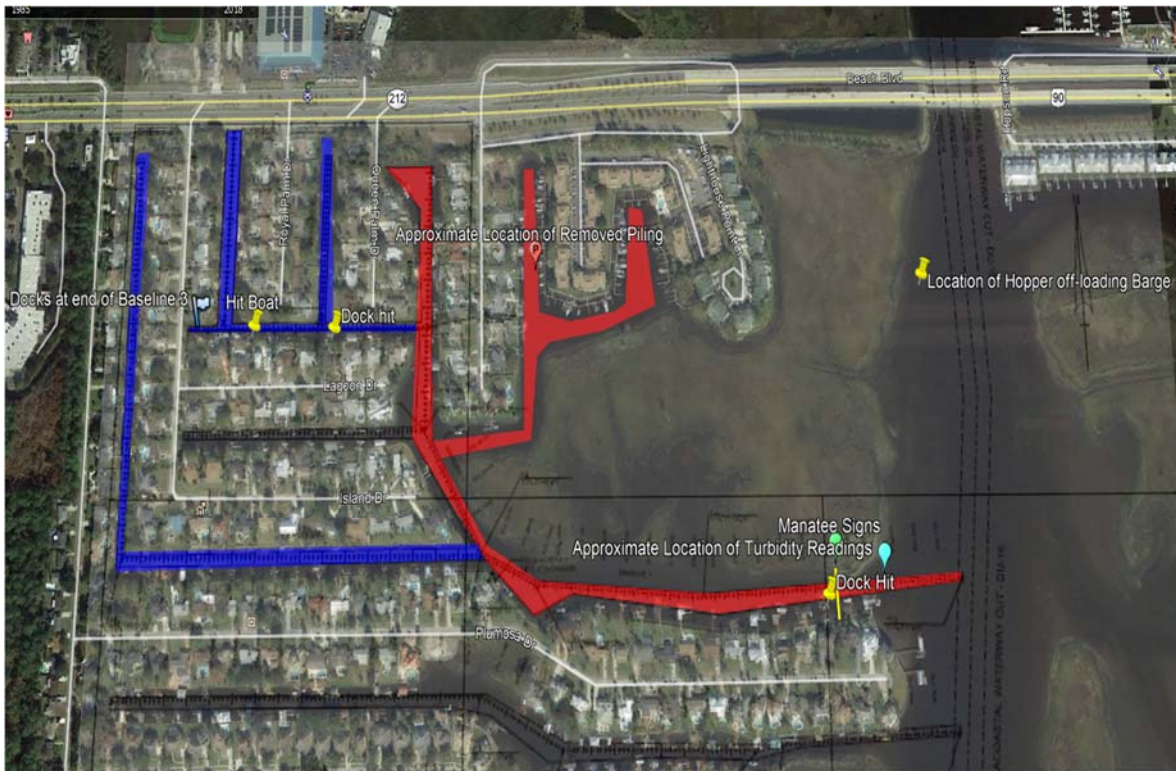
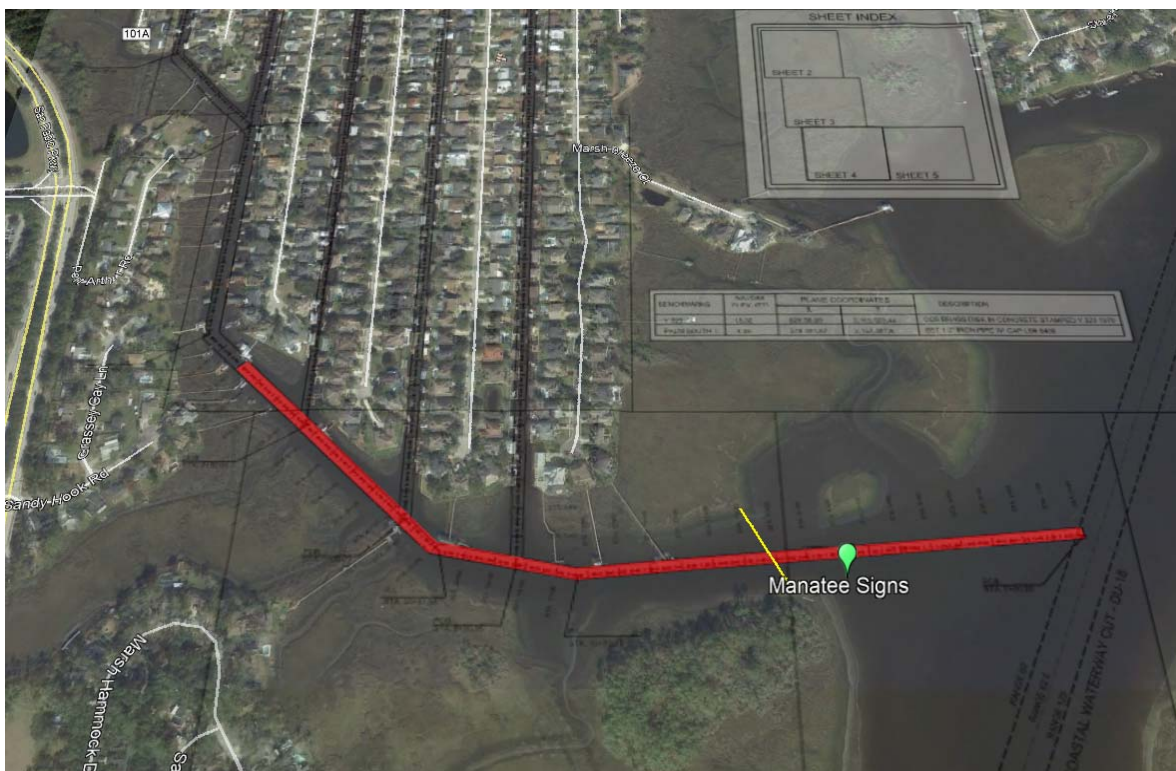
**Maps: Red is completed Work Blue is Work to be completed**

| Item | Observations | Photo |
|---|--|--|
| <b>Work Completed</b> | <p>S Baseline 1 to ~ Station 31<br/> N Baseline 1 to terminus<br/> Mooring Canals<br/> Portions of N Baseline 2, 3, &amp; 5</p> <p>Mooring Canals are currently where all the barges are actively dredging. BDI indicated that Mooring canals should be completed, and a second Arc Survey should be conducted by the end of the week.</p> <p>BDI indicated that Baseline 3 will be the next canal completed to grade.</p> <p>BDI indicated that Baseline 5 has an input of material, likely to be from the rip rap along Beach BLVD, which is filling in the dredged portions of the canals.</p> <p><u>BDI advised dredging occurs in two phases: on the way in for access &amp; removal of top layer of sediment and on the way out for getting canal to</u></p> | See Map |

| | <u>specified grade. This is true for all canals that barges cannot initially access.</u> | |
